Date: July 8, 2004
Product: ASHTECH SOLUTIONS V 2.7
Subject: DOWNLOAD V 2.74
Number: AS 2004_06

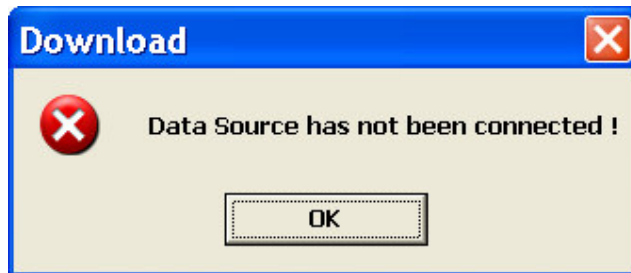
The Ashtech Solutions Download software can not connect to a LOCUS receiver through the IR port. The following message appears on the computer screen:

The problem can be fixed by using the old version of Download, V2.60
After the Ashtech Solutions V2.7 installation on your computer, overwrite the 2 following files in Ashtech Solutions/Bin folder

Dload32.exe (dated on 08/08/2002; 225 280 bytes)
Engine32.DLL (dated on 08/08/2002; 139 264 bytes)
