Potential Error in HI Measurements Due to Bending of Measurement Tape

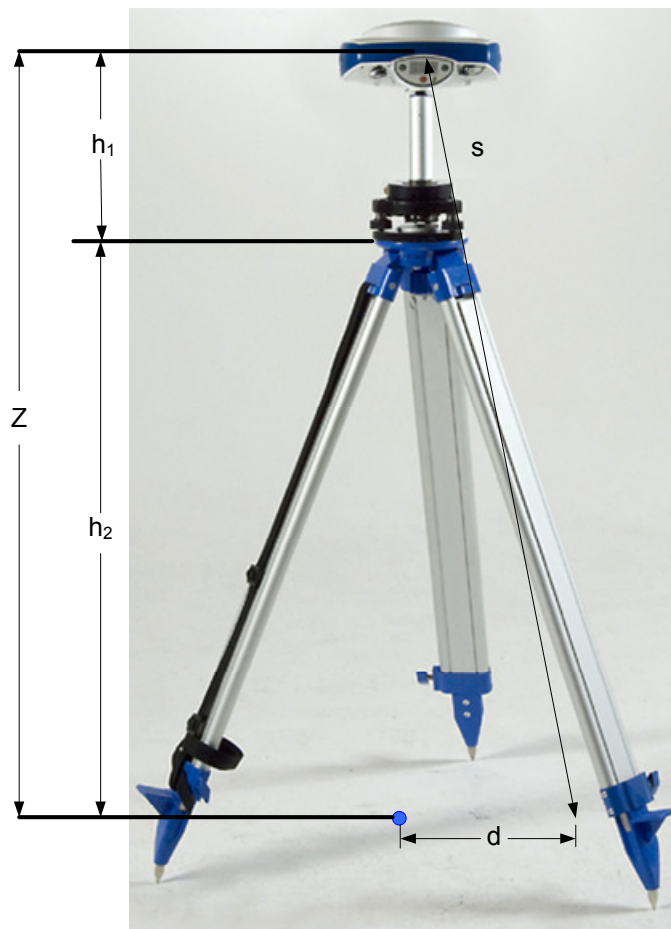
The following diagram illustrates the situation.

The surveyor wants height Z and is measuring slant-height s . There is an obstruction somewhere between the ProMark 500 height measurement hook and the point on the ground being measured. To calculate the error induced in the measurement s owing to the inability to measure directly to the point, one needs to know the following three values:

h_1 = vertical height from measurement hook to obstruction

h_2 = vertical height from obstruction to point on the ground

d = offset distance from the point on the ground to where the tape meets the ground *without touching* the obstruction.

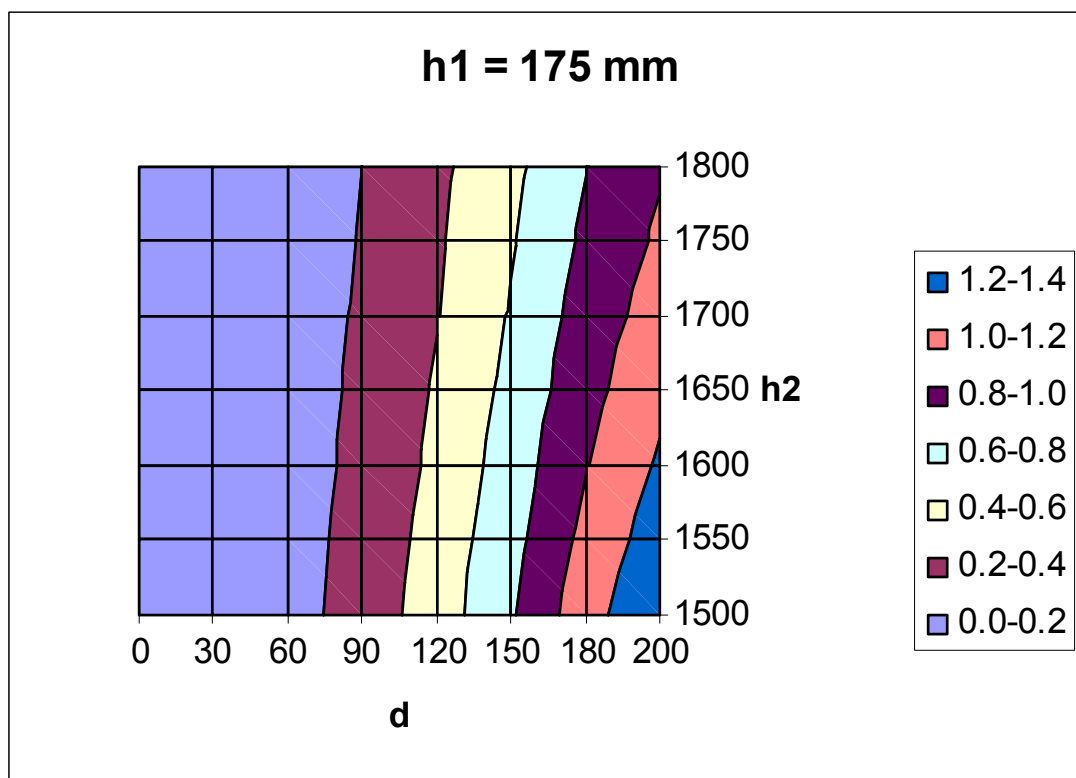
For the case where h_1 is 175 mm (typical when the HI extension that is shipped with the ProMark 500 is used), and where h_2 is between 1500 and 1800 mm, the following chart shows the error induced when the tape is shifted by the amount d from the true point. It can be seen that the error due to bending the tape exceeds 0.5 mm only when the distance d is greater than 100 mm to 120 mm, depending on the height of the tripod.

In conclusion, it is clear that the error induced by bending of the measurement tape is negligible in most situations. Care should always be taken to prevent bending the tape during slant height measurement, but small amounts of bending cause negligible error.

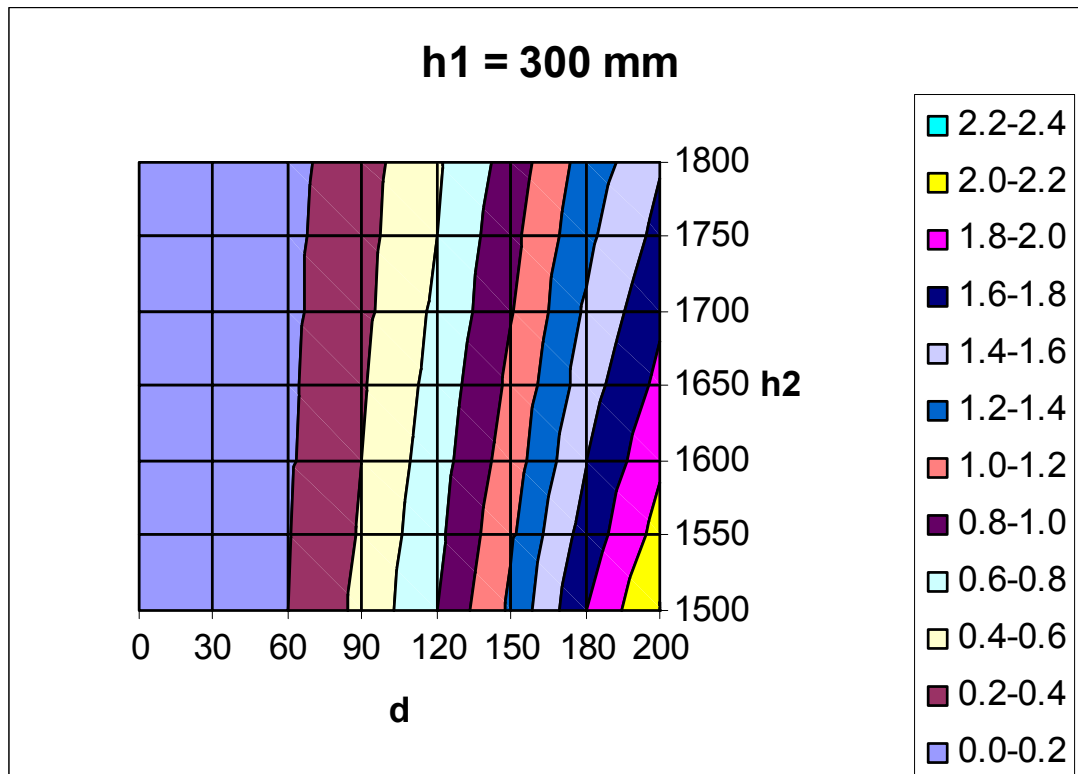
For the case where $h_1 = 300$ mm, the following graph applies. It is seen that the error is made greater when h_1 is increased.
