Date: March 08, 2005
Product: Allegro CE & FAST Survey V1.50.024
Subject: FAST Survey and Socket Bluetooth Com Port
Number: Z_Max2005_03

It may occur that the FAST Survey does not detect the correct Bluetooth com port after a “Restore System” depending on the Socket Bluetooth card version.

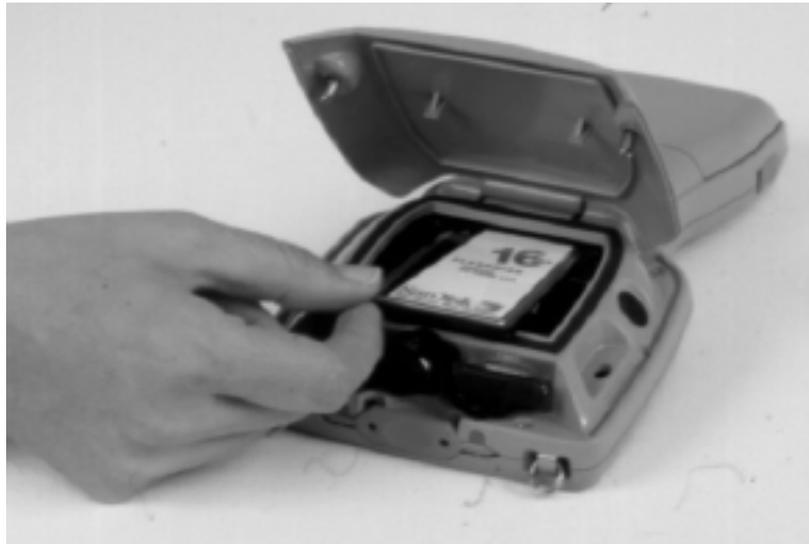
Make sure that the Socket Bluetooth card is inserted in the field terminal slot.

To insert the Socket Bluetooth card, loosen the two screws on the back of the field terminal and insert the card as shown below.
